MG ROVER GROUP

SERVICE ACTION BULLETIN

No: AD186 Issue 1

HOOD DAMAGE DURING FOLDING – ADDITIONAL FRAME STRAPS

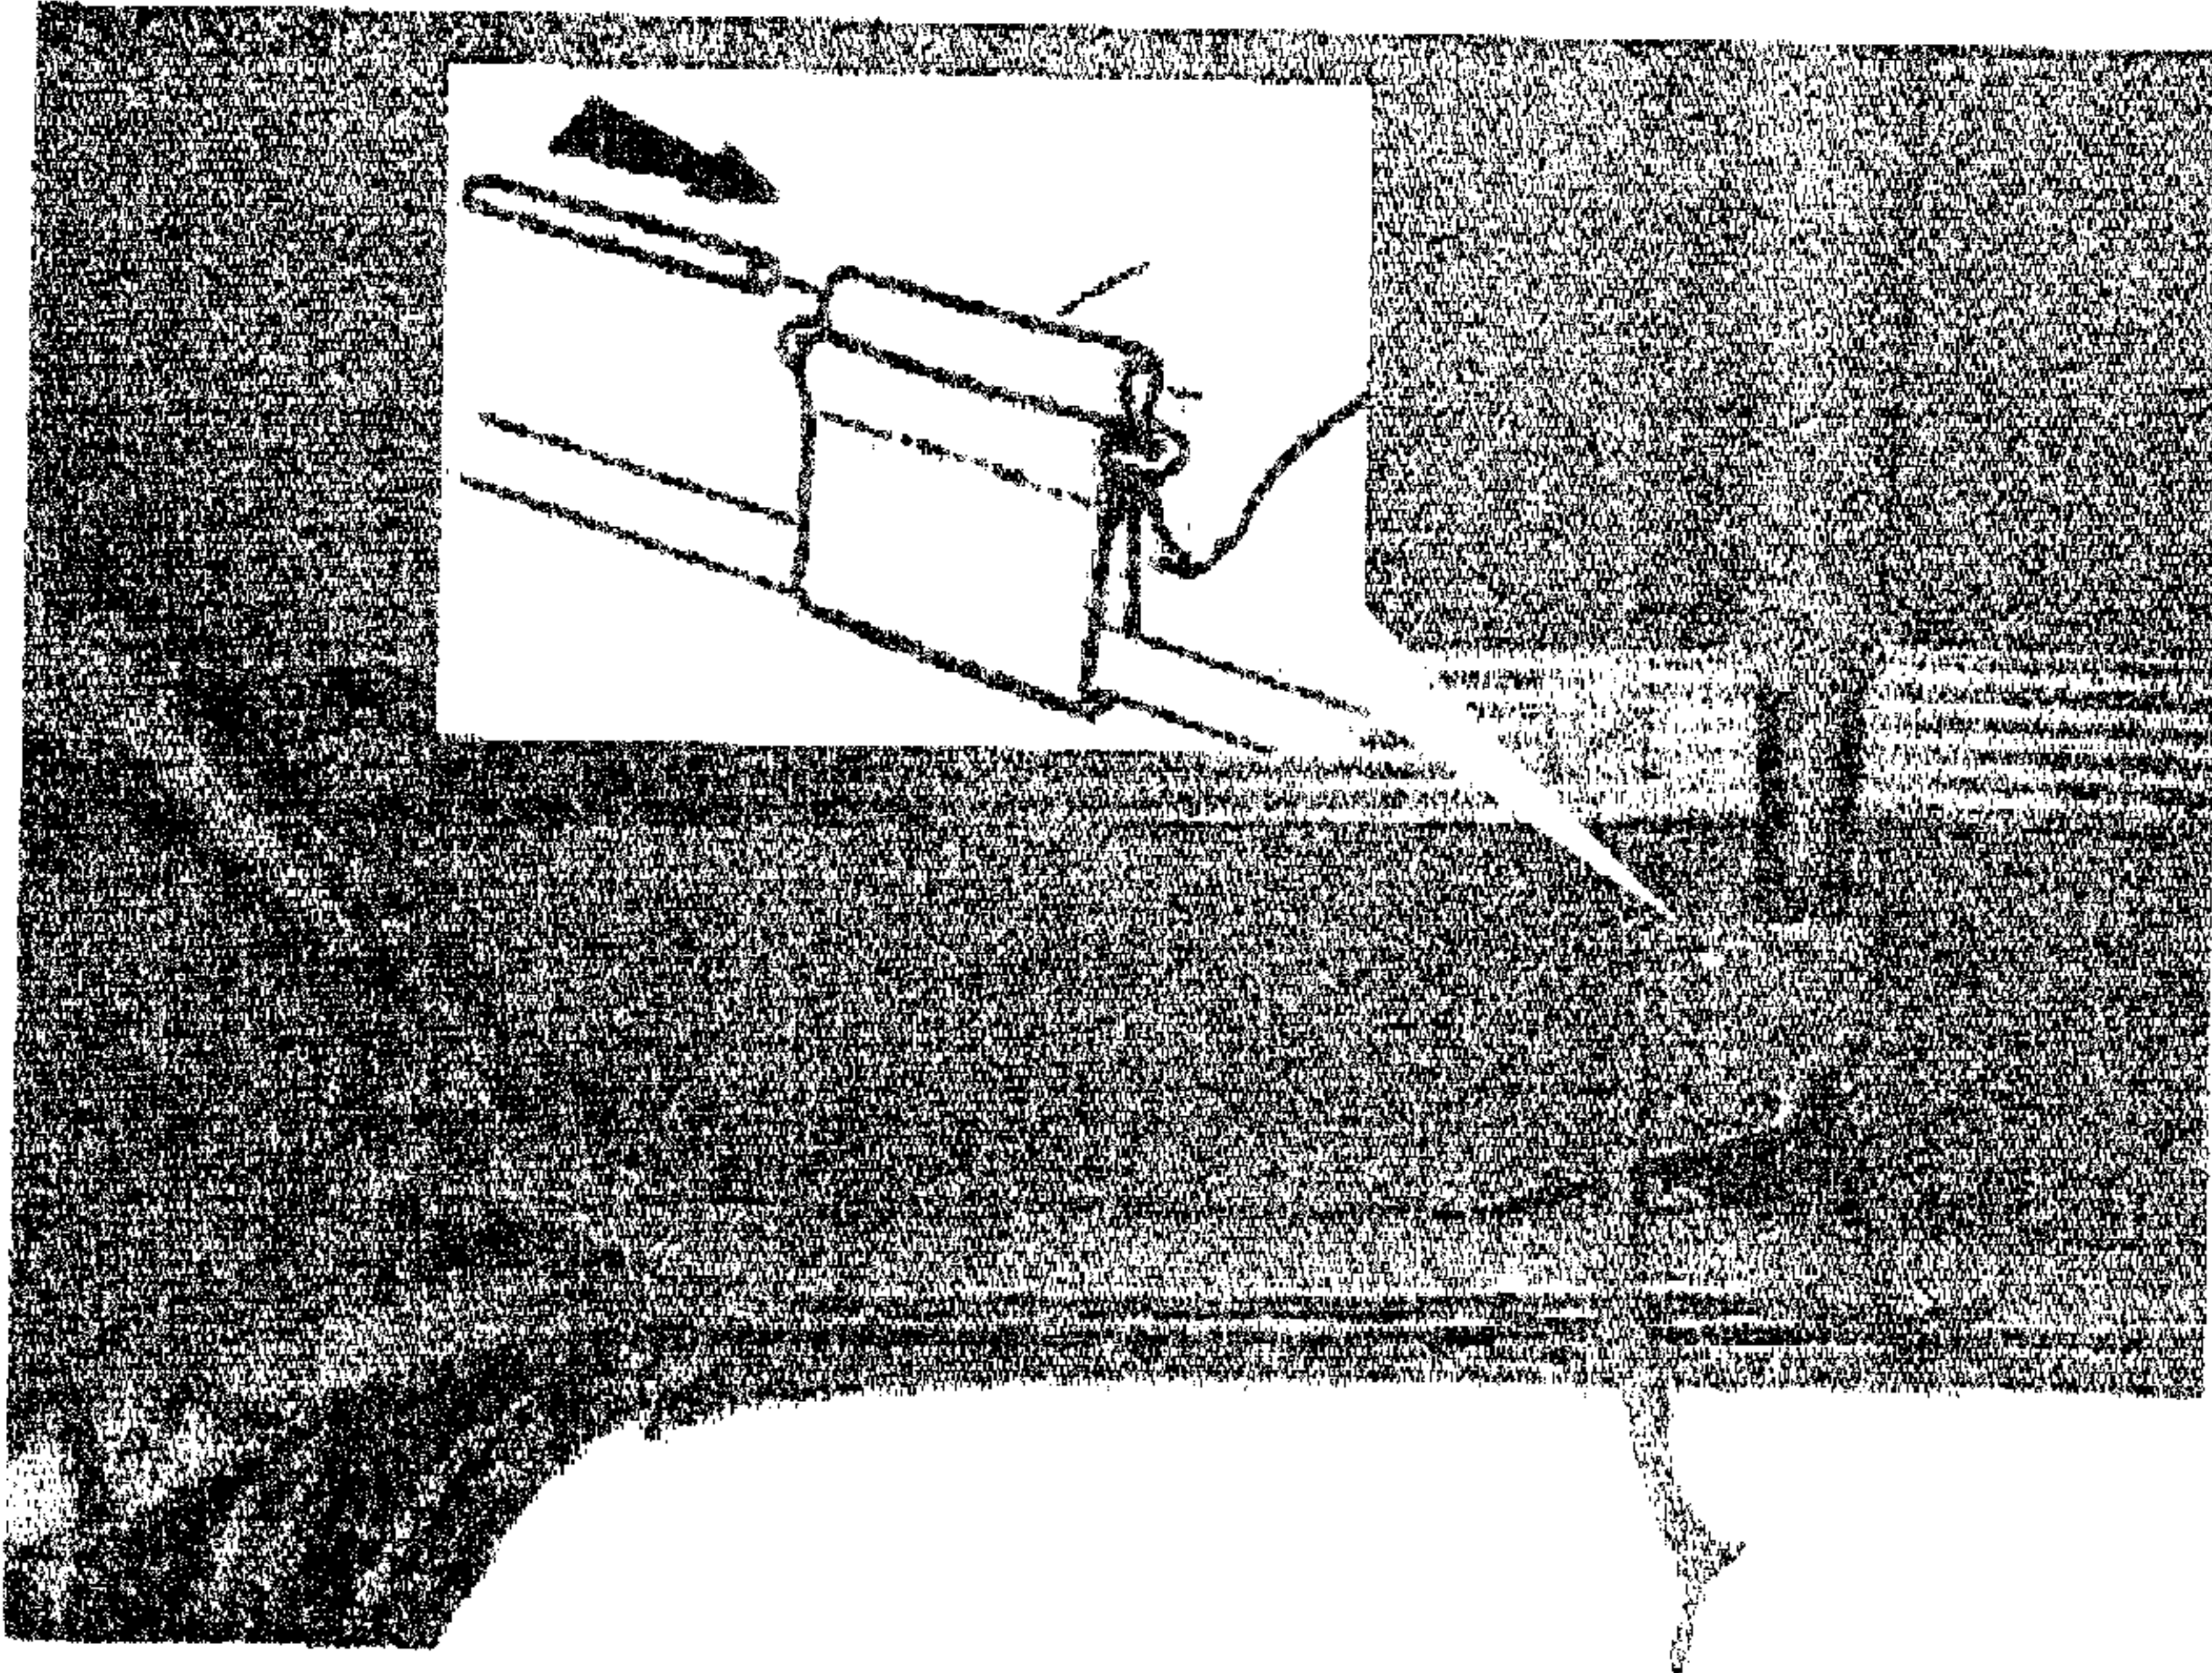
1. Lower both windows fully down.
2. With reference to illustration 1 and the hood in the raised position, fit strap to 1st frame rail ensuring that the strap buckle with fastening pin faces the front of vehicle. The strap must be positioned between the existing hood strap and the hood side levers as shown.

Attaching straps to rail: Remove pin from its stitched pocket and feed the buckle end of strap over the rail to form a loop. Feed the empty pin pocket through the buckle and re-insert the pin into pocket, the strap will now be secured to the rail. When fitted, the strap buckle must face the inside of vehicle (not facing the hood material).
